Conditions Assessment

Mt. Everett Academy

June 2014

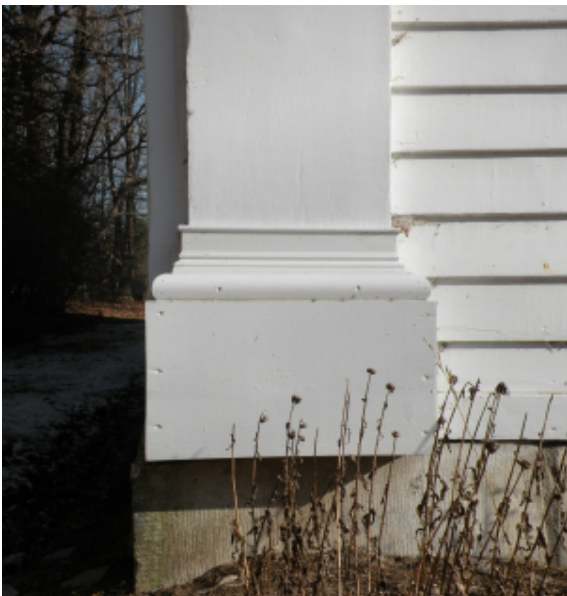
Image 18. A close comparison of the molding details drawn in the 1930s and the existing conditions reveals that some of the Greek Revival moldings have been replaced over time.

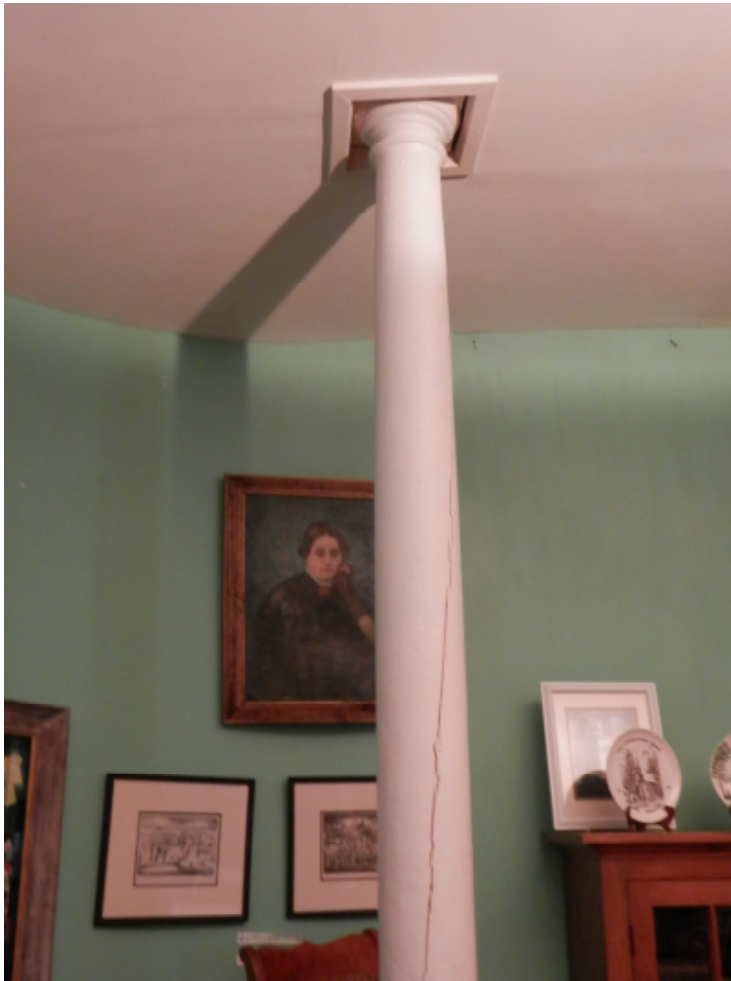
The primary item of concern relates to the “checking” visible in one of the wooden columns on the second floor [Image 21]. It is possible that this condition is caused by stresses from the belfry framing loads although solid timber posts such as these hand planed columns tend to check. Secondly, the water staining at the ceiling in the first floor of the addition corresponds with a heat duct register in the floor directly above. It is likely a result of condensation in the hot air duct above the cool space in the room below.

Image 21. Significant checking is visible in the columns.

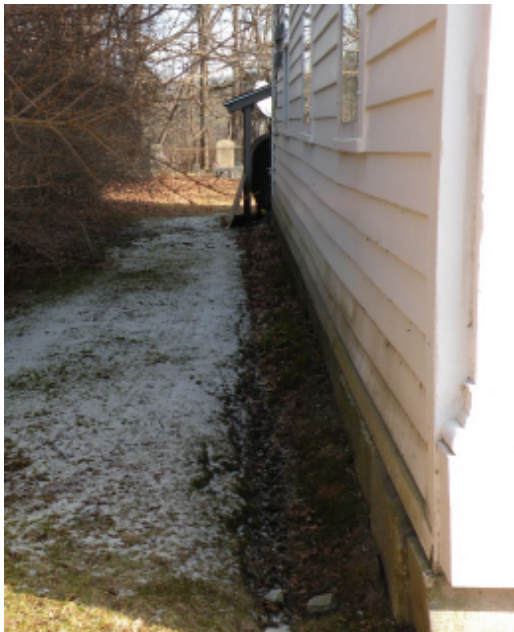
The north and south sides of Mt. Everett Academy are particularly affected because all of the roof run-off is concentrated at these locations. Additionally, the roof run-off has eroded the earth directly below the drip-line so that the ground slope is no longer directing water away from the foundation and is exposing foundation stone once covered by earth [Image 18]. Splash-back from the roof and stone settlement are the probable causes of the mortar deterioration.

Image 22. Roof run-off has eroded the earth directly below the drip-line so that the ground slope is no longer directing water away from the building.

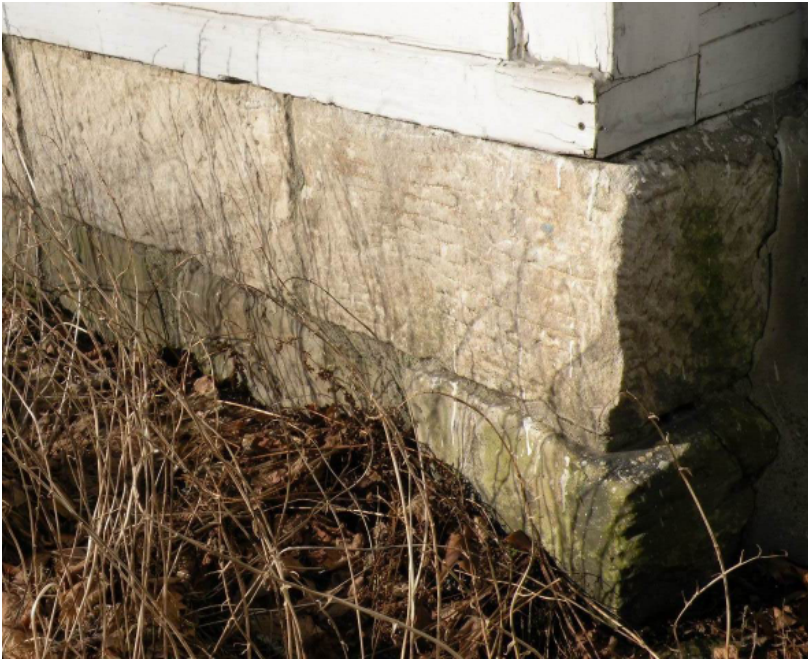
Image 23. Erosion has revealed a lower course of blocks at the South Elevation that are roughly leveled with a pitching chisel. These were not originally intended to be seen.

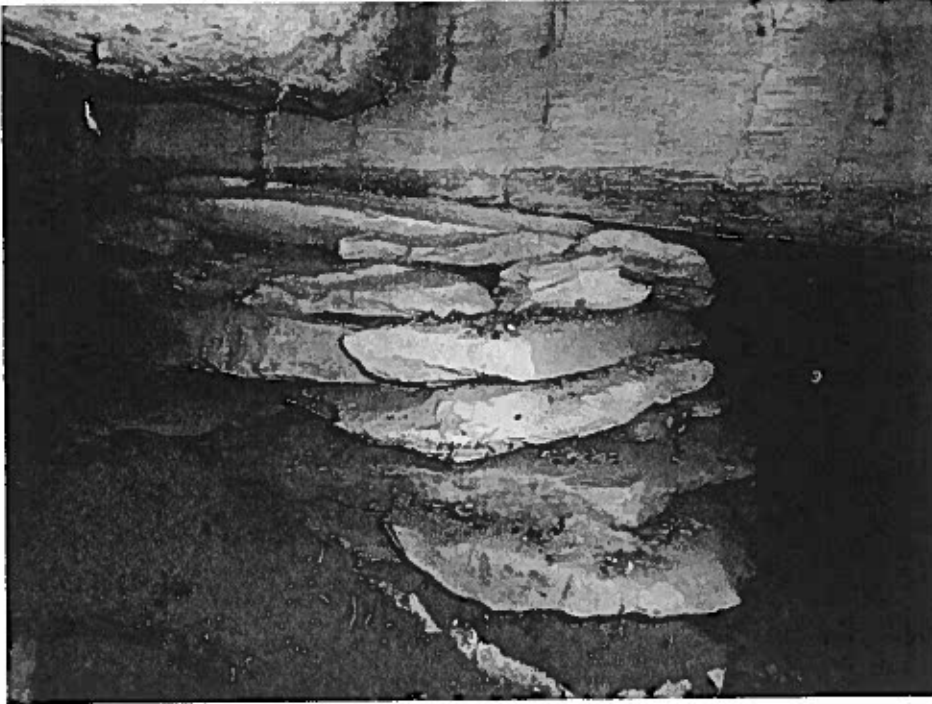
Underside of flooring system; west pier at center of west beam. Note differential settlement of field stones.

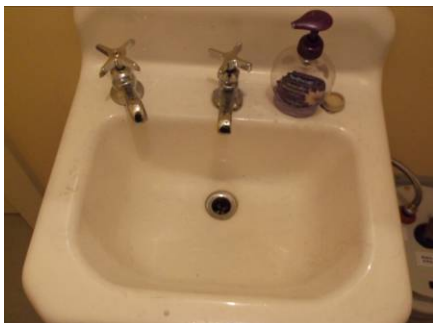
A wall mounted lavatory was observed in the bathroom. Piping beneath the fixture is copper for domestic and pvc for sanitary. The lavatory appeared to be over twenty five (25) years old and in fair condition. Replacement is warranted due to age, water consumption and for future ADA upgrades.

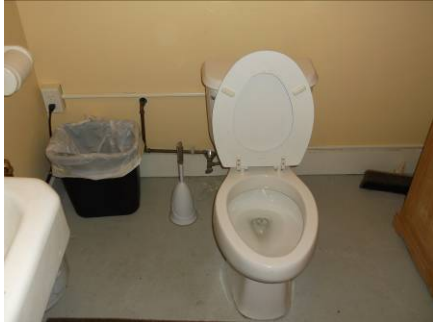
The bathroom is equipped with a tank type water closet located adjacent to the lavatory. The water closet is manufactured by the Kohler Company and appears to be in fair condition. Replacement is warranted due to water consumption and for future ADA upgrades.

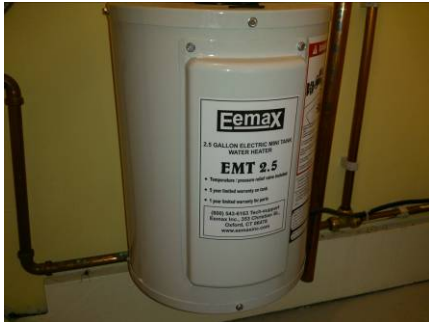
A point of use domestic hot water heater is located in the bathroom. The electric heater is manufactured by Eemax, Inc. and has a capacity of two and a half (2-1/2) gallons. The unit has been recently installed and is in good condition. No mixing valve for the domestic hot water was present. Relocate to mechanical room due to future ADA upgrades and add mixing valve.

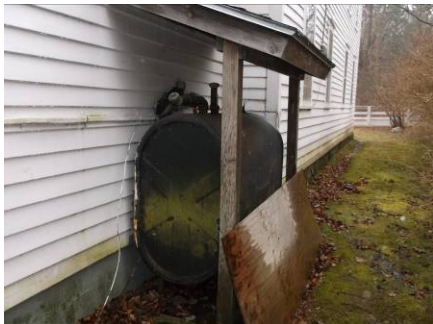
One (1) above ground #2 fuel oil tank was observed at the building's exterior. The tank has a capacity of two hundred and seventy five (275) gallons with an integral heater. There appears to be deterioration present on the tank's enclosure. Fuel oil supply line from the tank is routed to the oil fired burner in the mechanical room. Tank replacement is warranted due to condition.

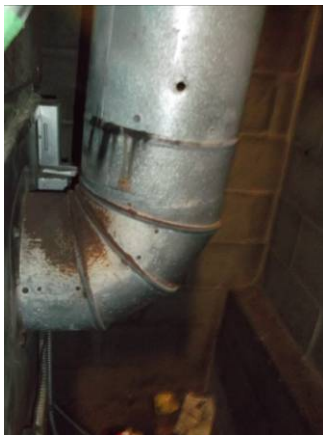
Flue breeching for the furnace is routed to an chimney stack and appeared to be in poor condition with deterioration at the furnace connection point. Replacement is warranted due to condition.

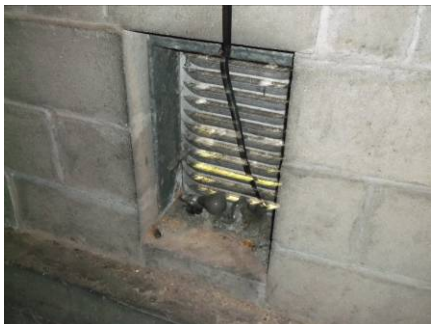
Combustion air for the furnace is provided by an exterior louver located in the mechanical room. The louver appeared to be in fair condition with debris at the sill.

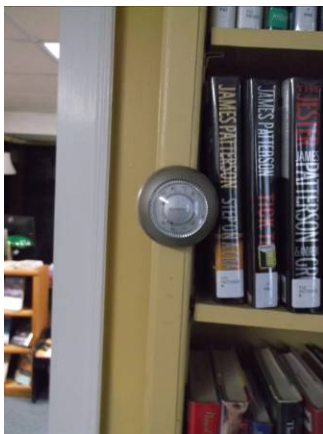
Three (3) wall mounted non-programmable thermostats manufactured by the Honeywell Company were observed. Two (2) thermostats are located in the first floor library area and the one (1) located in the open area on the second floor. The thermostats appeared to be over twenty five (25) years old and in fair condition. Replacement is warranted due to age.

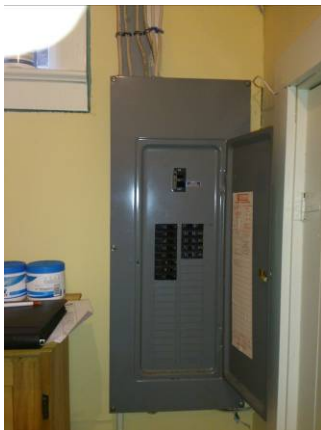
The electrical panel is a Square D QO load center rated at 200 amperes at a 120/240V, 1-phase, 3-wire voltage configuration. It is currently located in the bathroom which is also a violation of the current MEC.

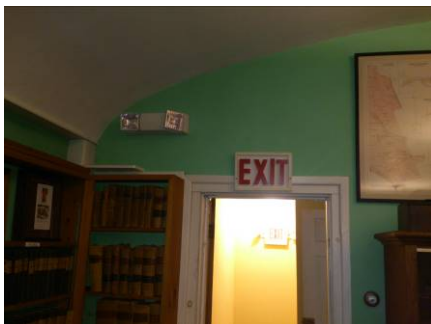
A dual head emergency light was observed between the two main rooms on the first floor. However, this fixture was non-functional. A dual head emergency light fixture was also observed in each stairway. The heads on the rear stairway fixture need to be adjusted.

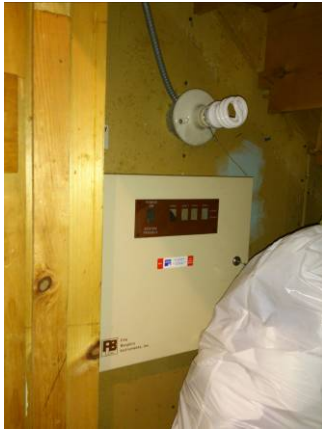
The building fire alarm system consists of a four zone conventional fire alarm control panel (FACP) located in the storage closet in the bathroom. Although, the FACP is a four zone panel, only one zone has been installed and monitors the entire building. A separate digital alarm communicator transmitter located adjacent to the FACP has been installed for communication to central station monitoring. The FACP was installed in March of 1986 with the battery being replaced in September of 2010.
